Technical Report CERC-96-8
September 1996

Periodic Inspection of Burns Harbor North Breakwater, Indiana

Report 1 Base Conditions

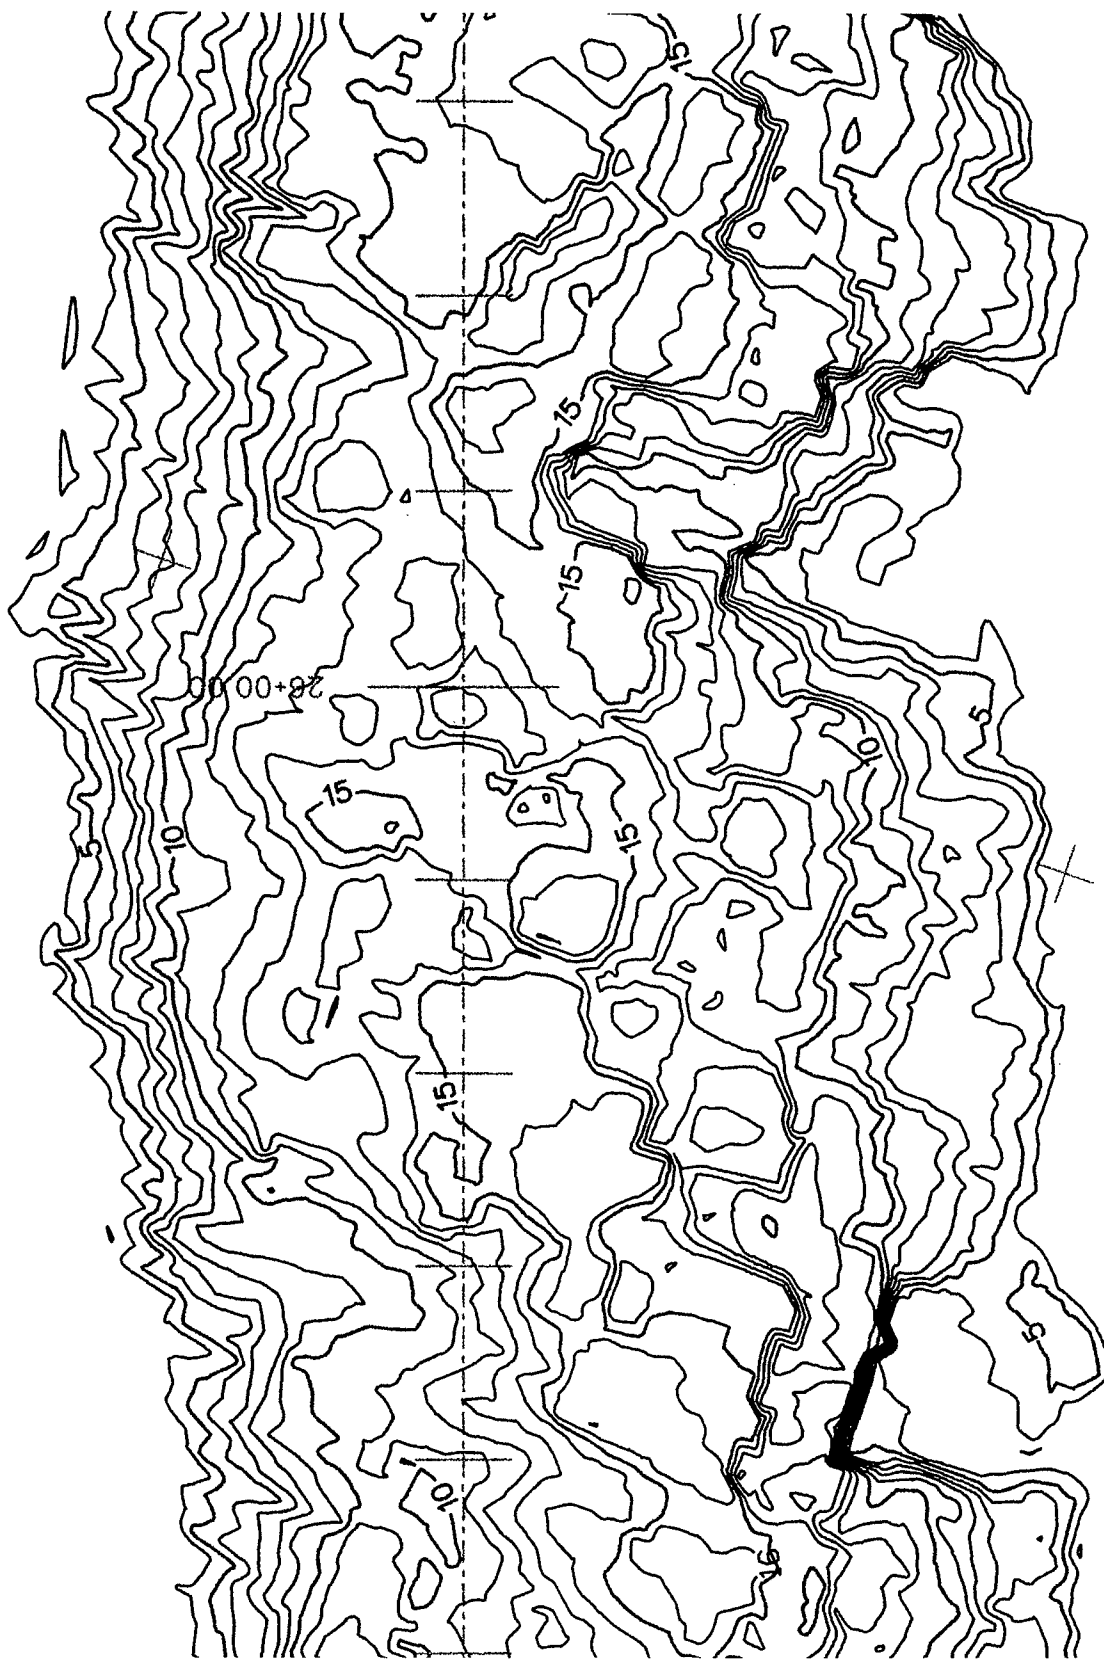
Figure A31. Topography of Burns Harbor North Breakwater, sta 25+65-26+50

This appendix presents contour maps of the Burns Harbor North Breakwater. Topography was developed using the digital terrain model (DTM) as stated in the main text of this report. The breakwater topography is shown on a 0.3-m (1.0-ft) contour interval. Elevations shown are in feet referred to low water datum (lwd). To convert them to meters, multiply by 0.3048. Station numbering on the contour maps is from east to west (right to left). The scale of the maps is 25.4 mm = 3.05 m (1 in = 10 ft).

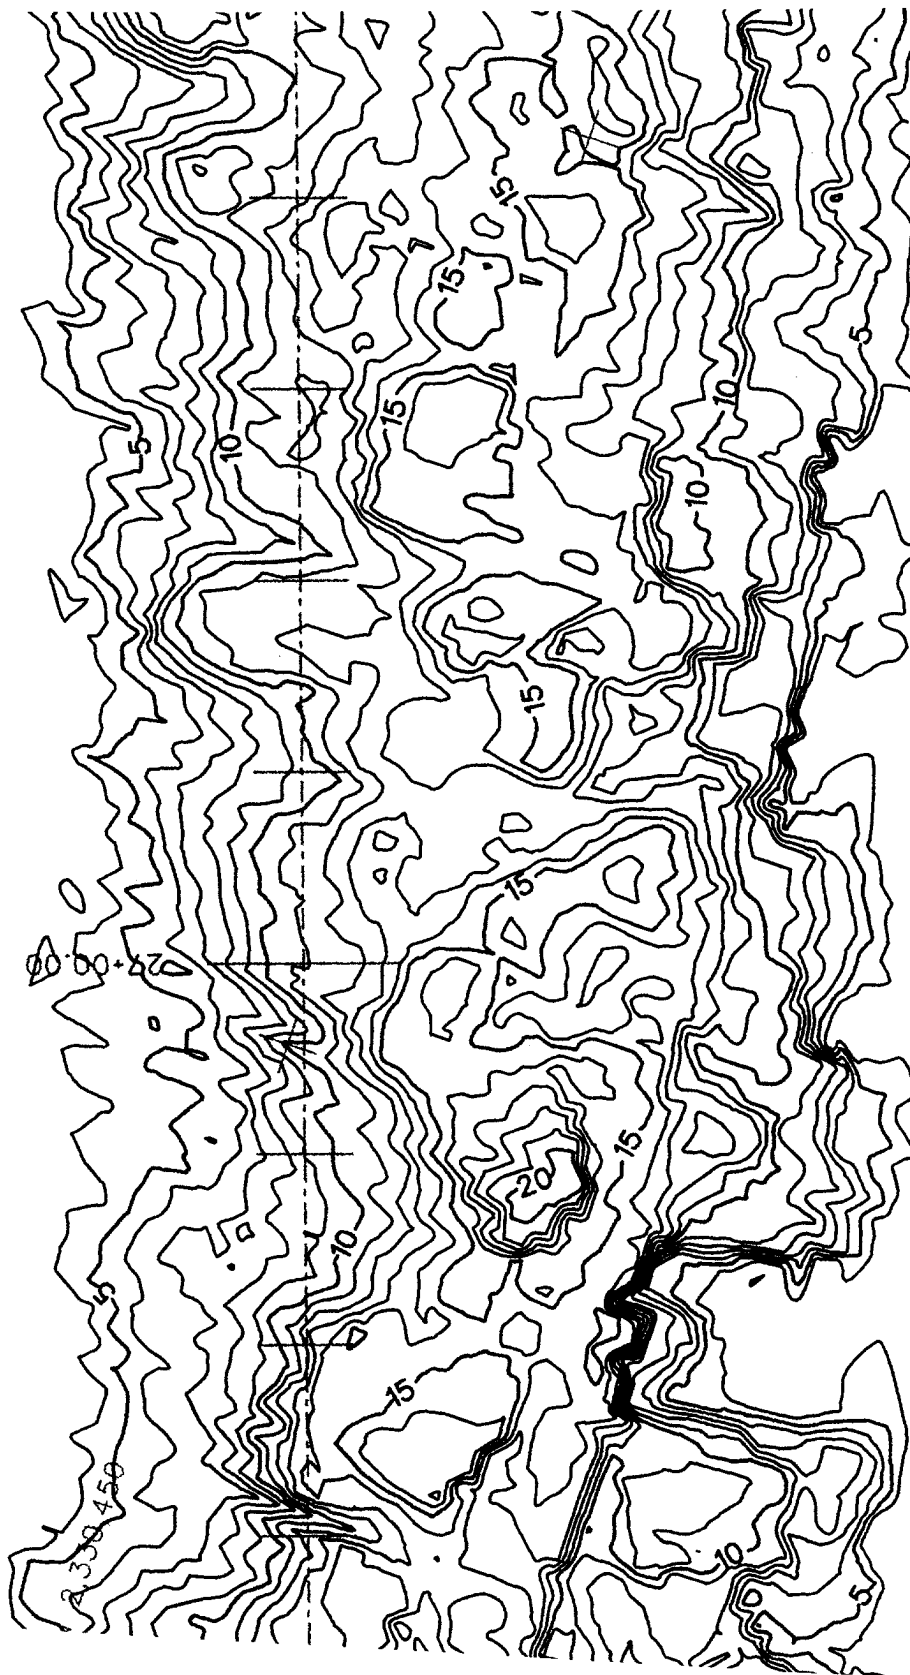
Figure A32. Topography of Burns Harbor North Breakwater, sta 26+50-27+36

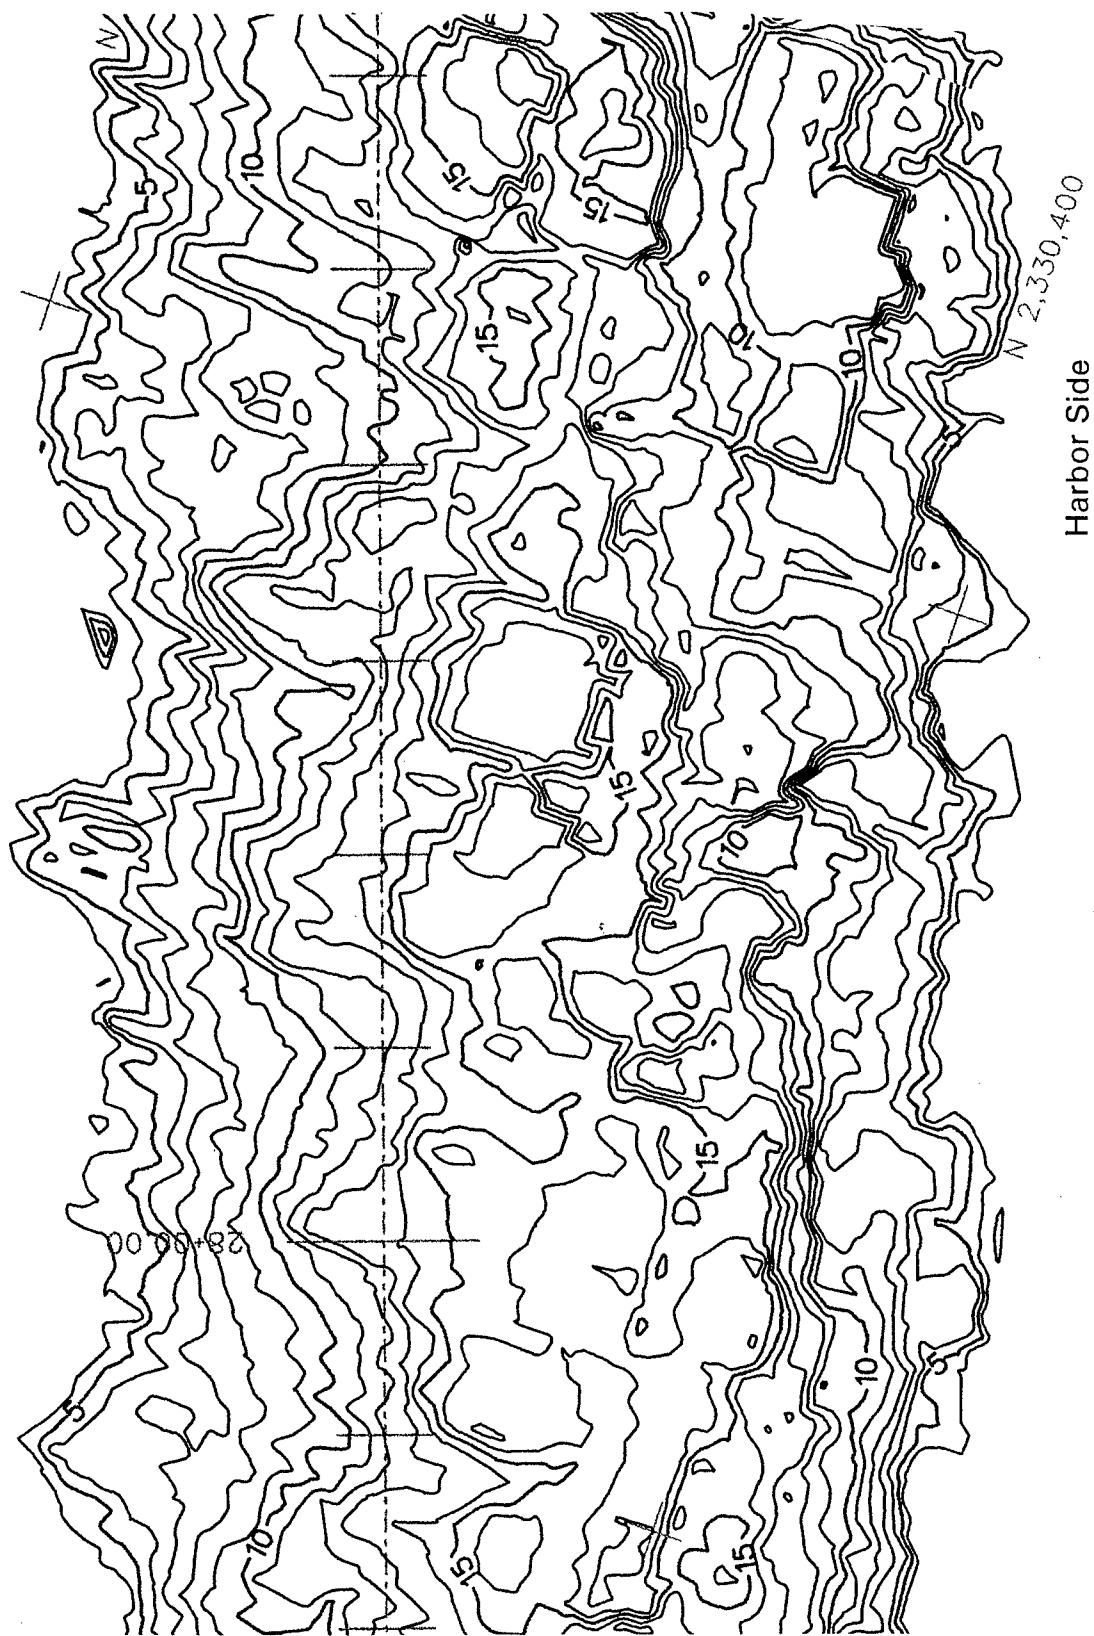
Figure A33. Topography of Burns Harbor North Breakwater, sta 27+36-28+20

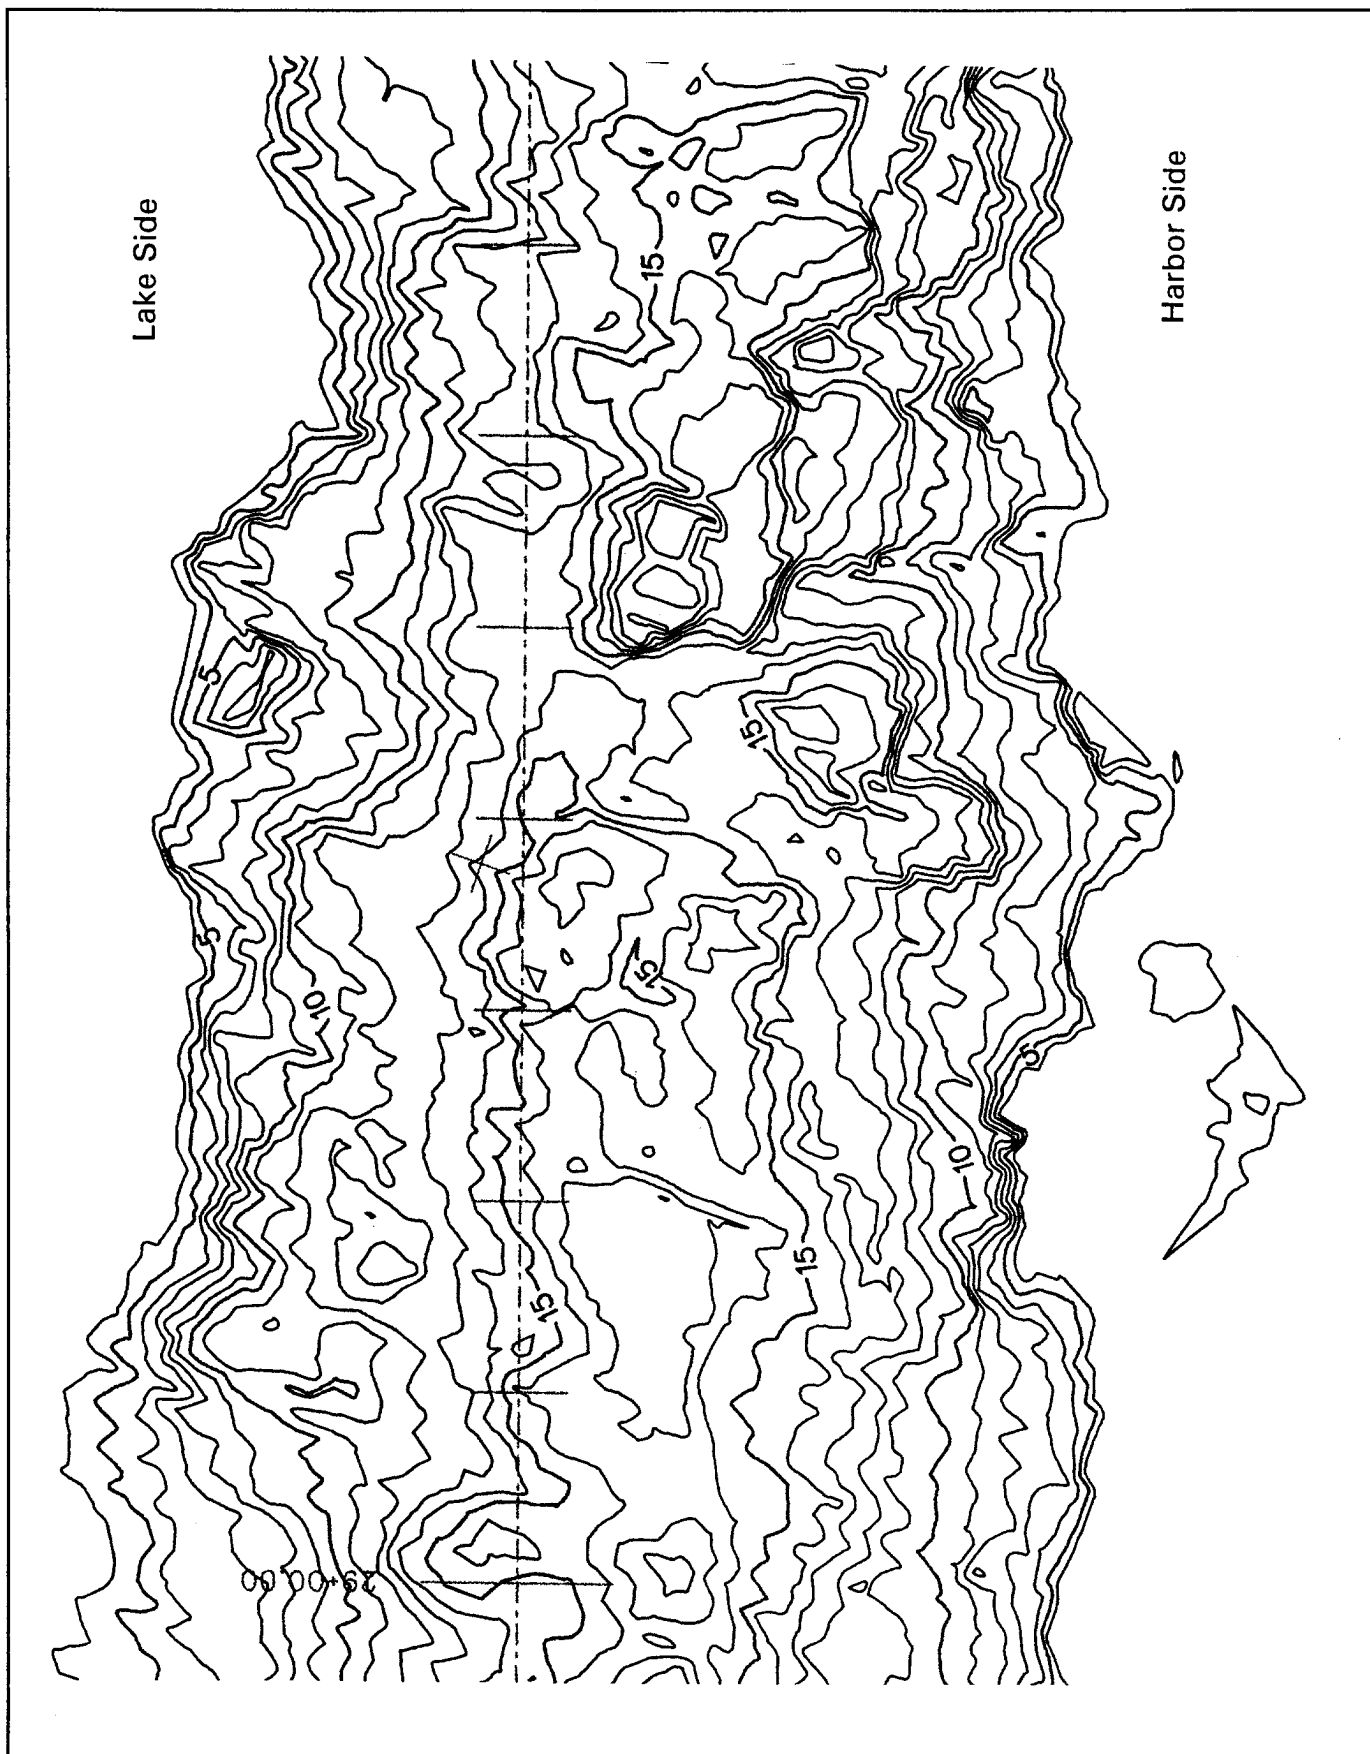
Figure A34. Topography of Burns Harbor North Breakwater, sta 28+20-29+05

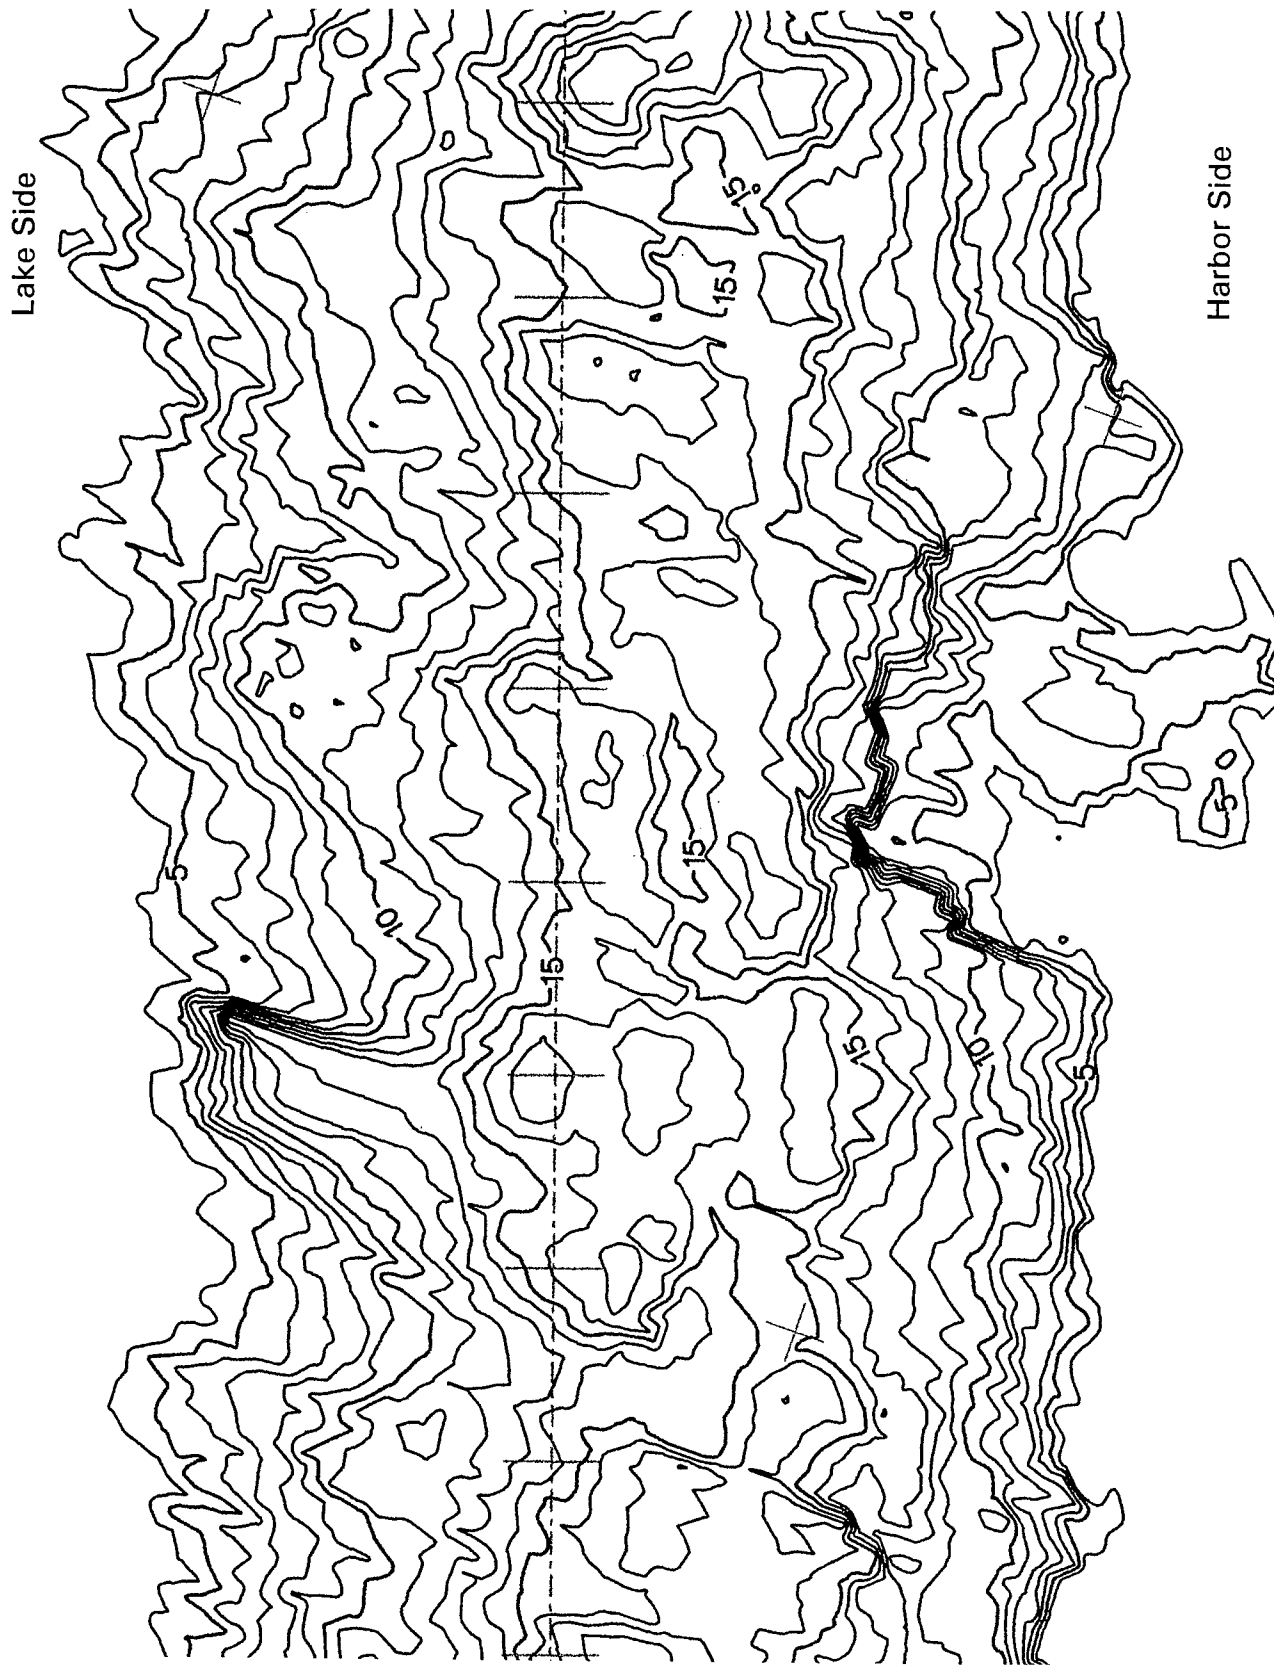
Figure A35. Topography of Burns Harbor North Breakwater, sta 29+05-29+90

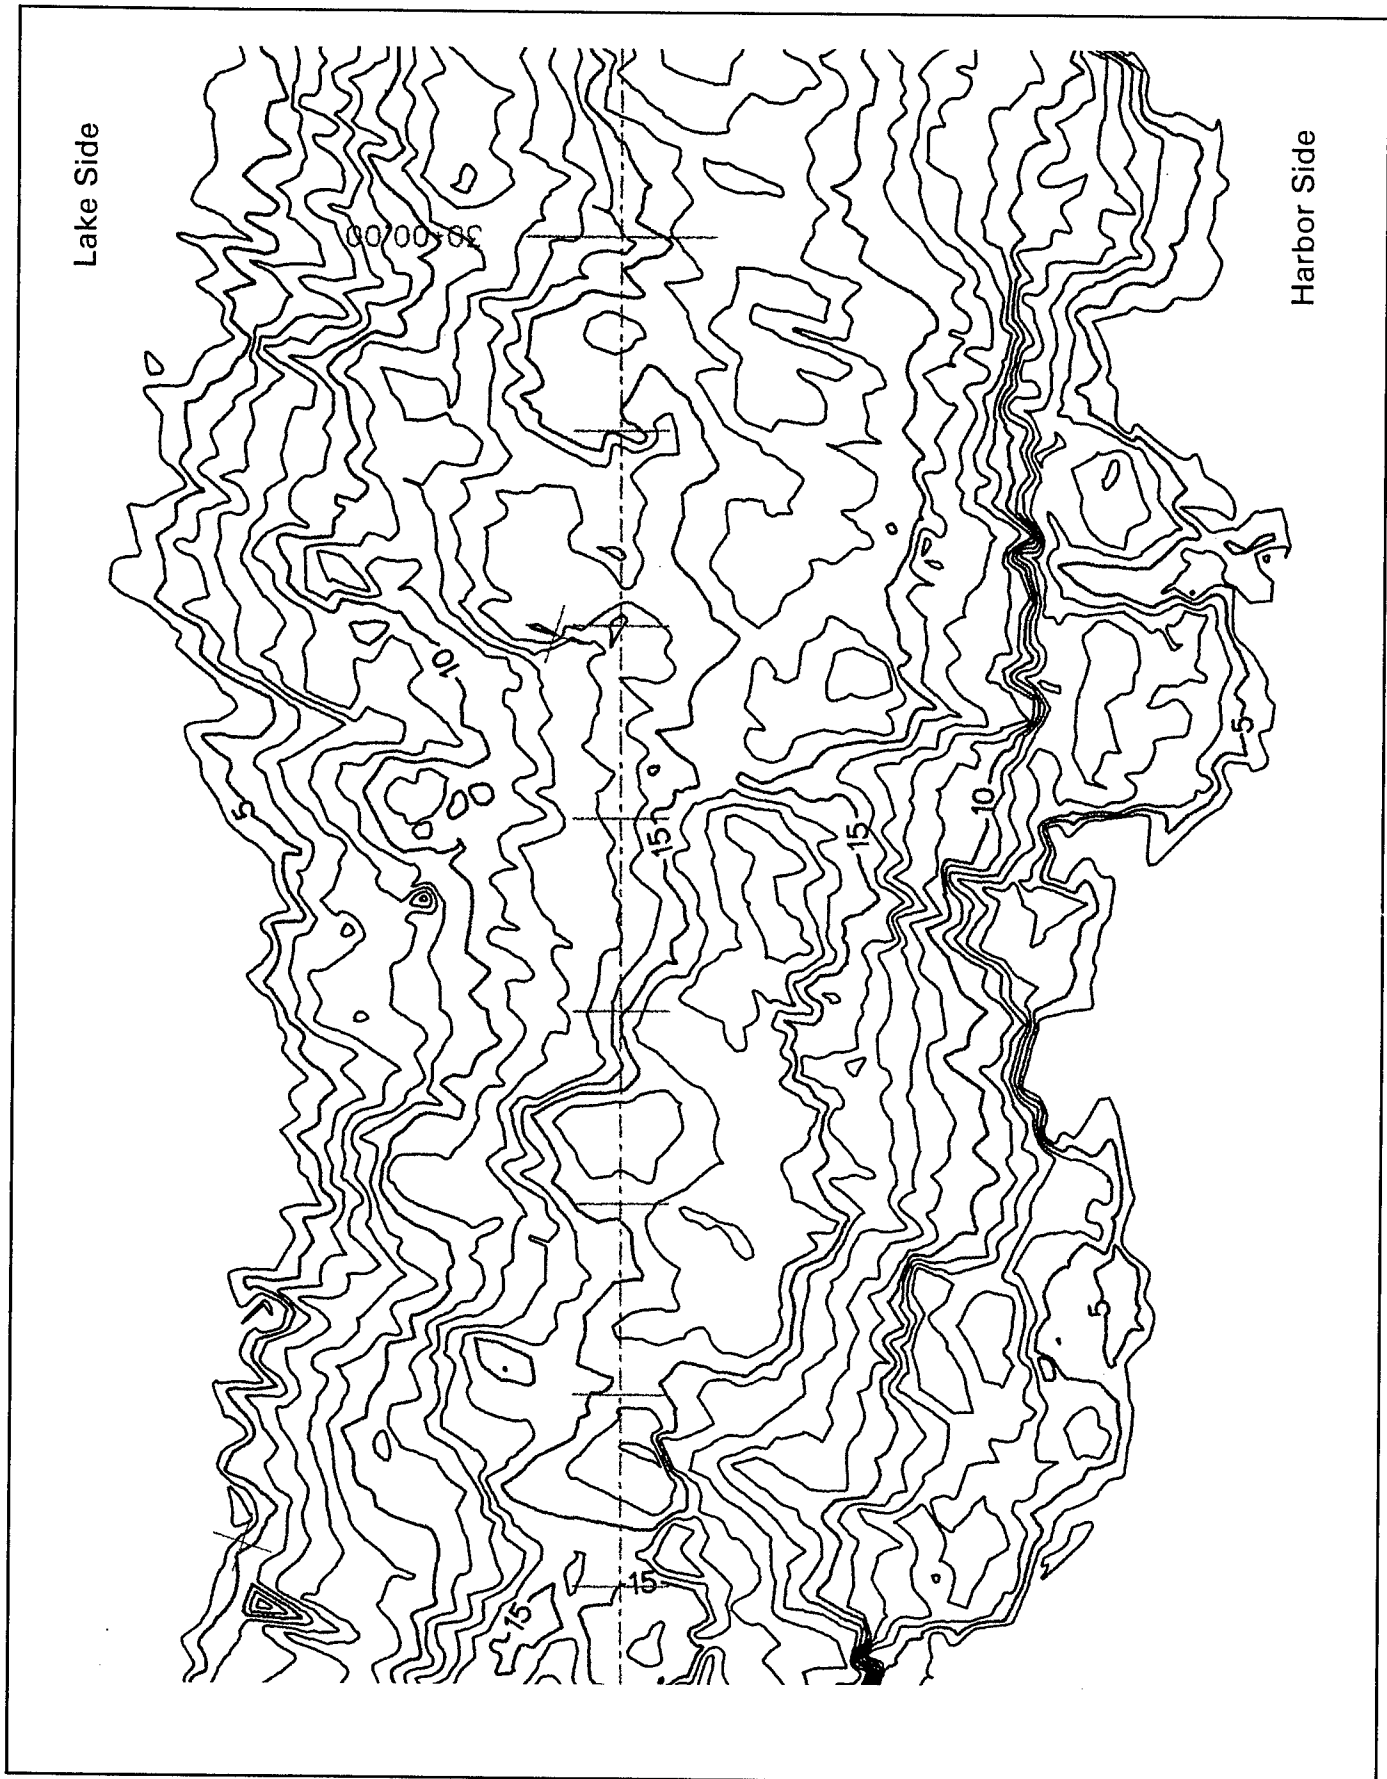
Figure A36. Topography of Burns Harbor North Breakwater, sta 29+90-30+75

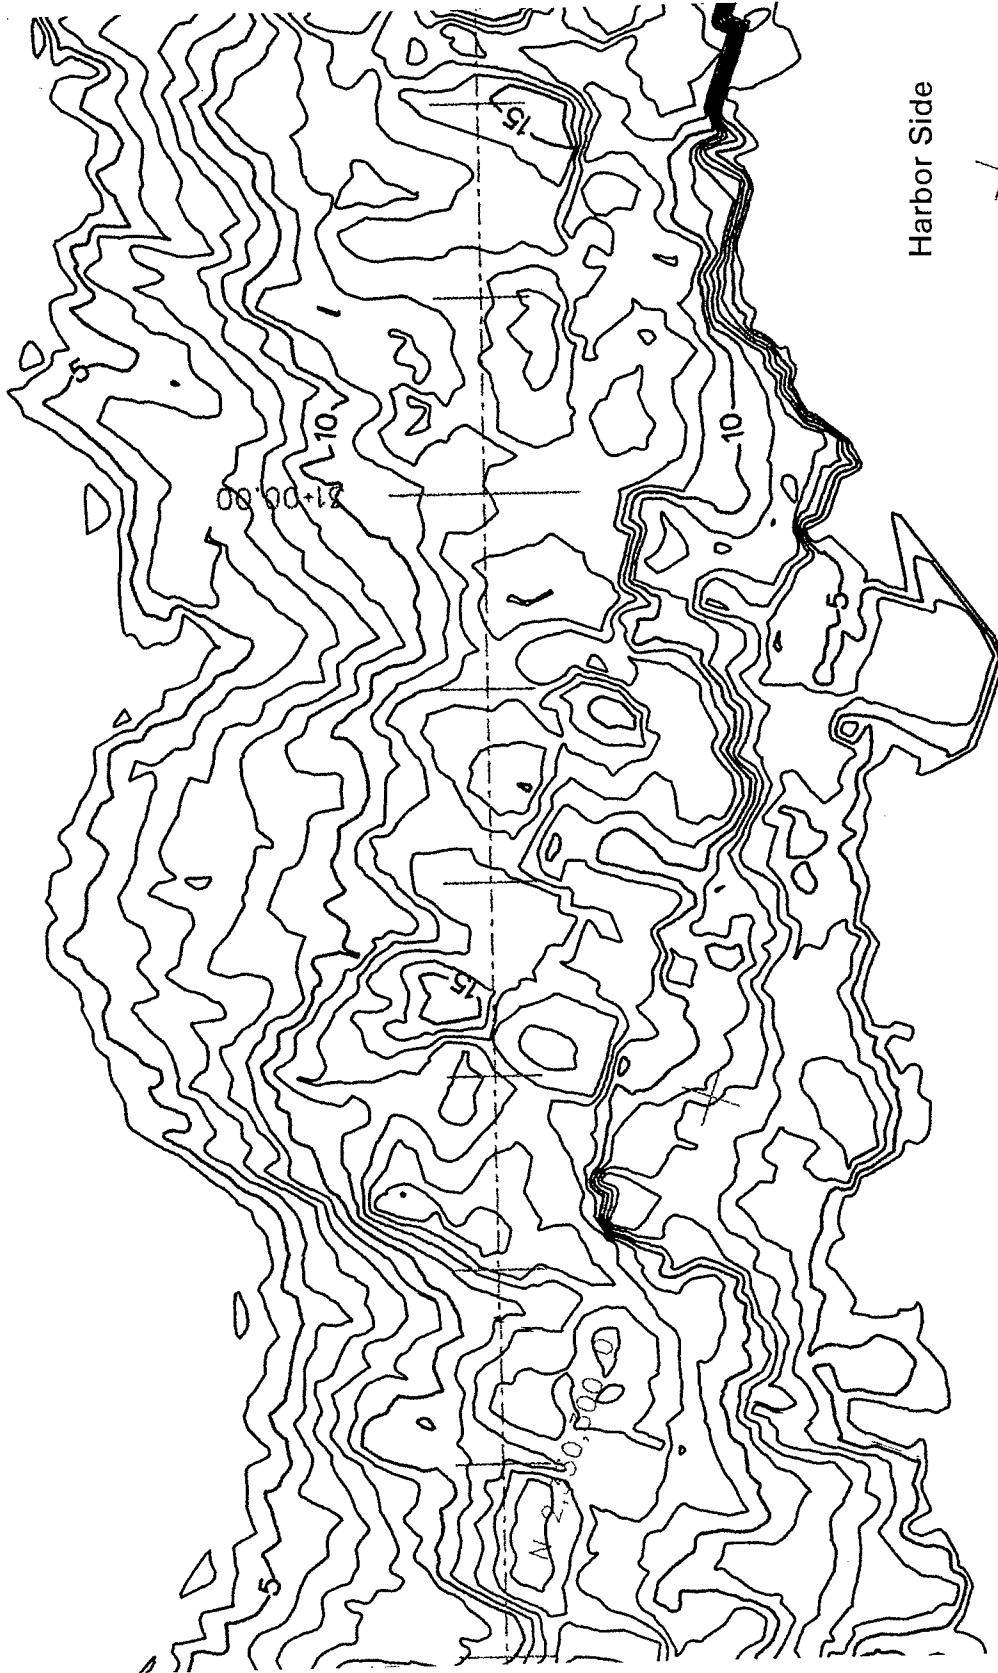
Figure A37. Topography of Burns Harbor North Breakwater, sta 30+75-31+60

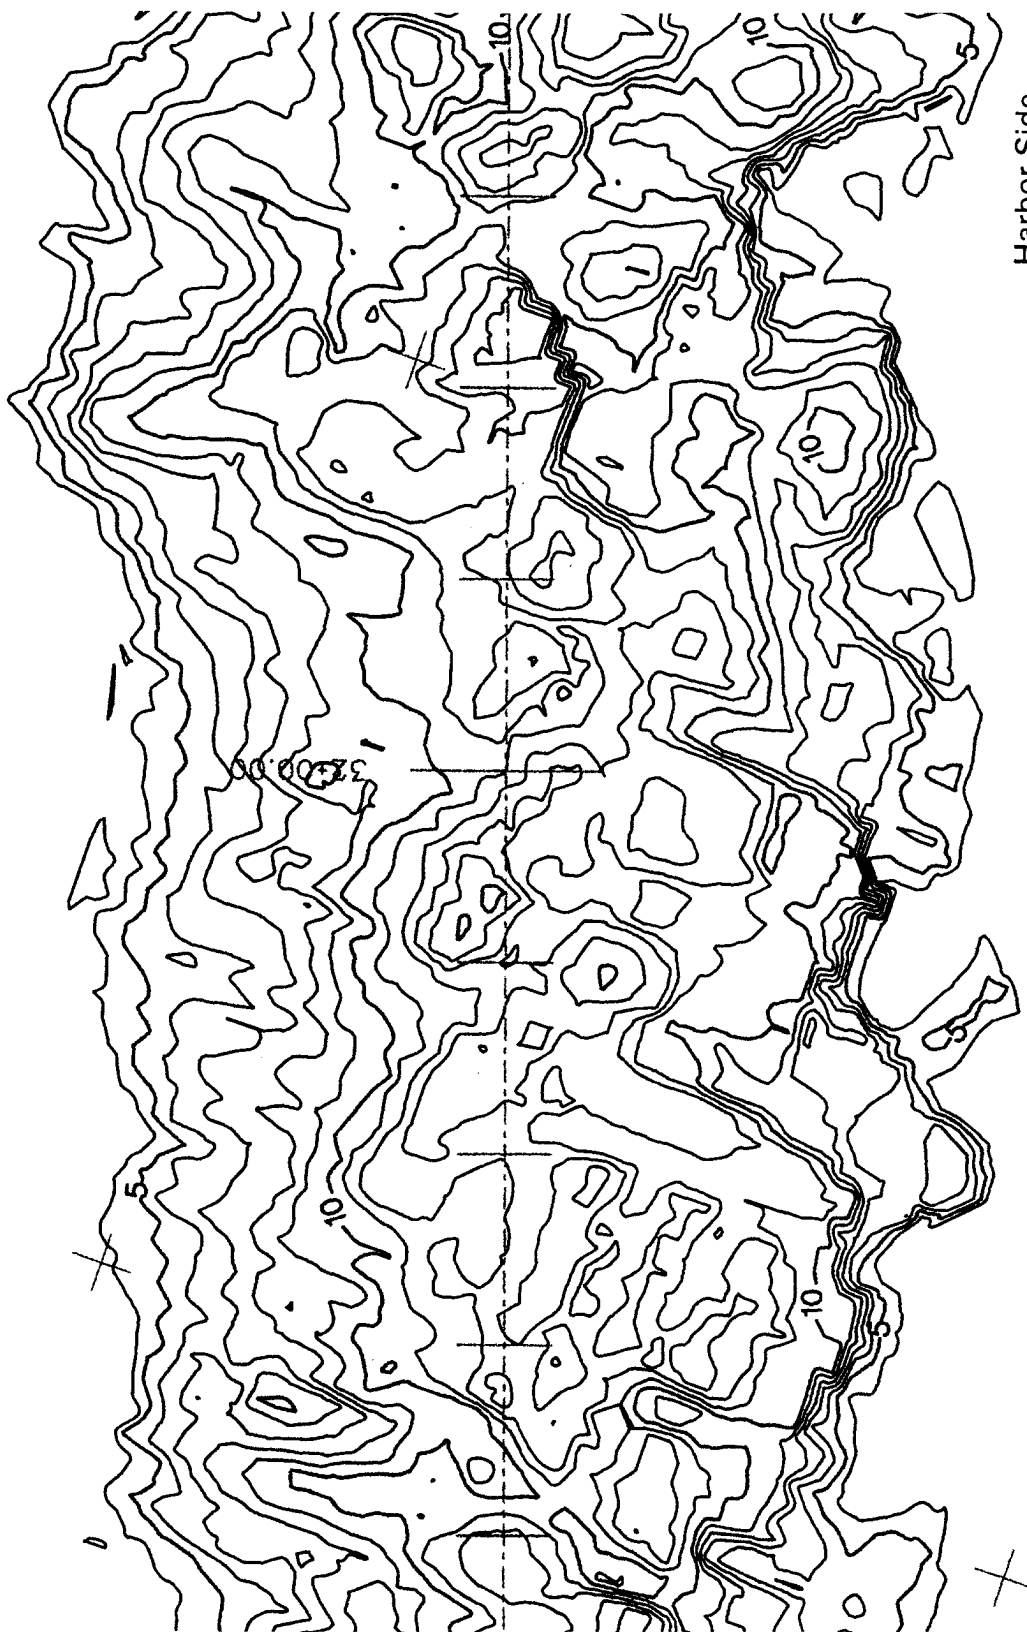
Figure A38. Topography of Burns Harbor North Breakwater, sta 31+60-32+45

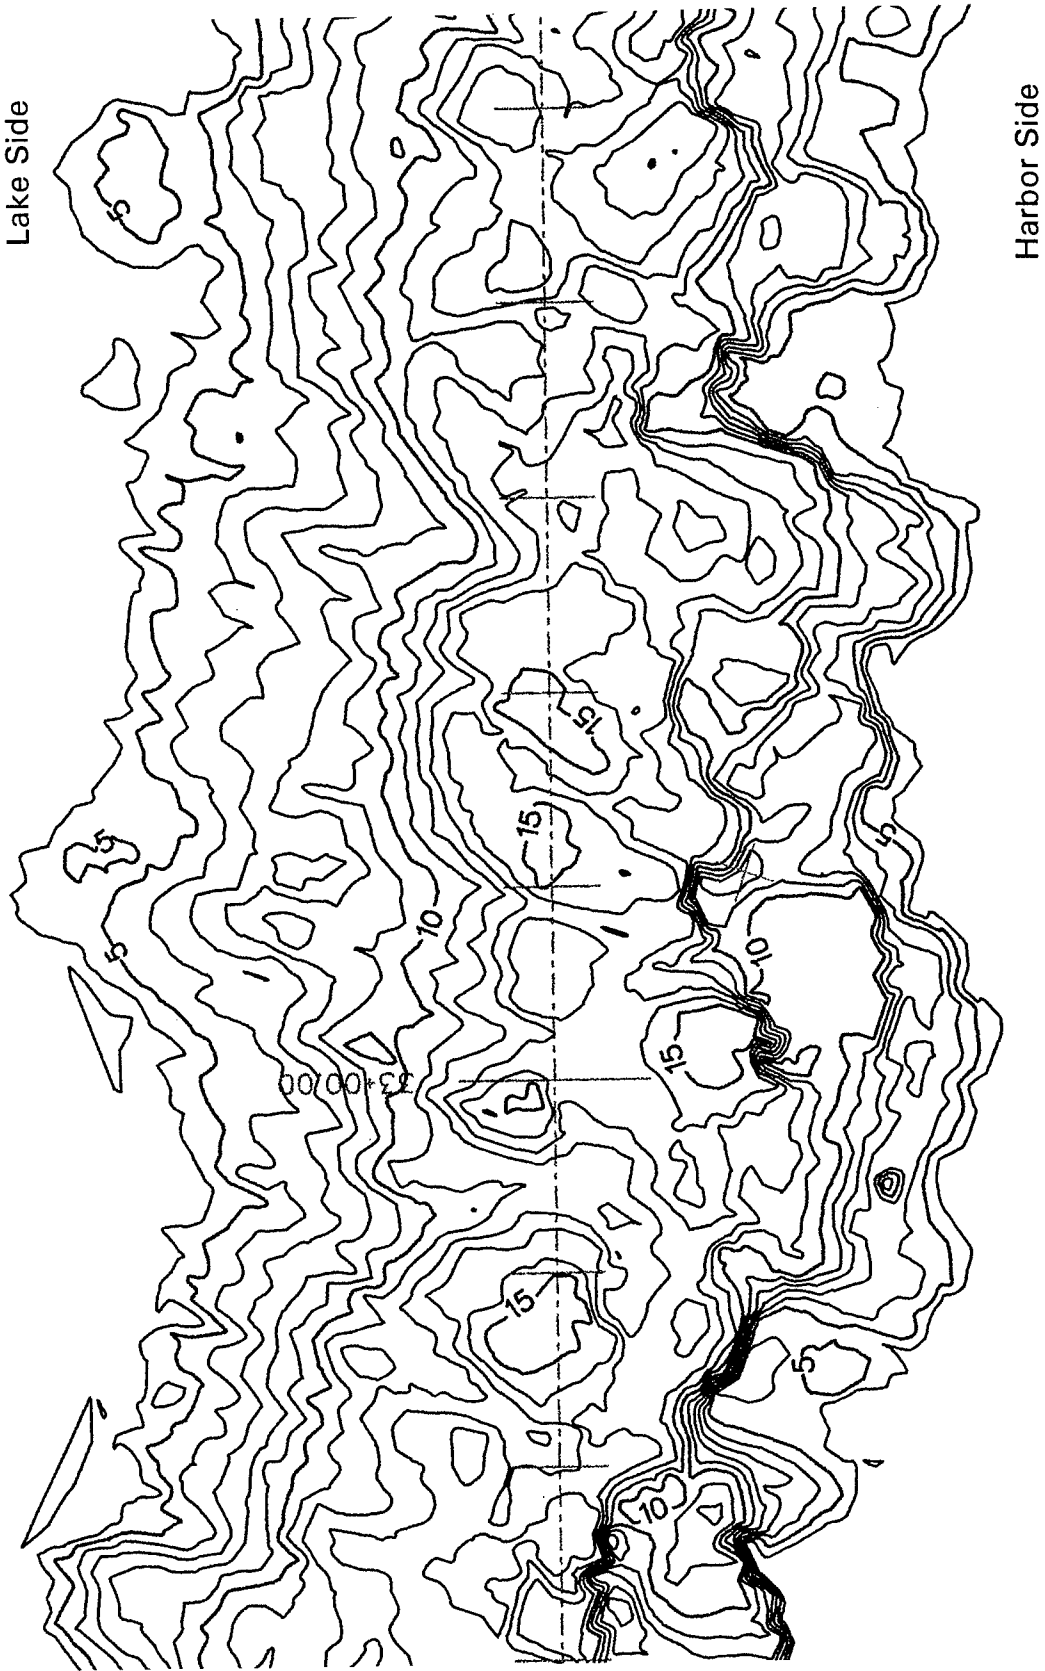
Figure A39. Topography of Burns Harbor North Breakwater, sta 32+45-33+30

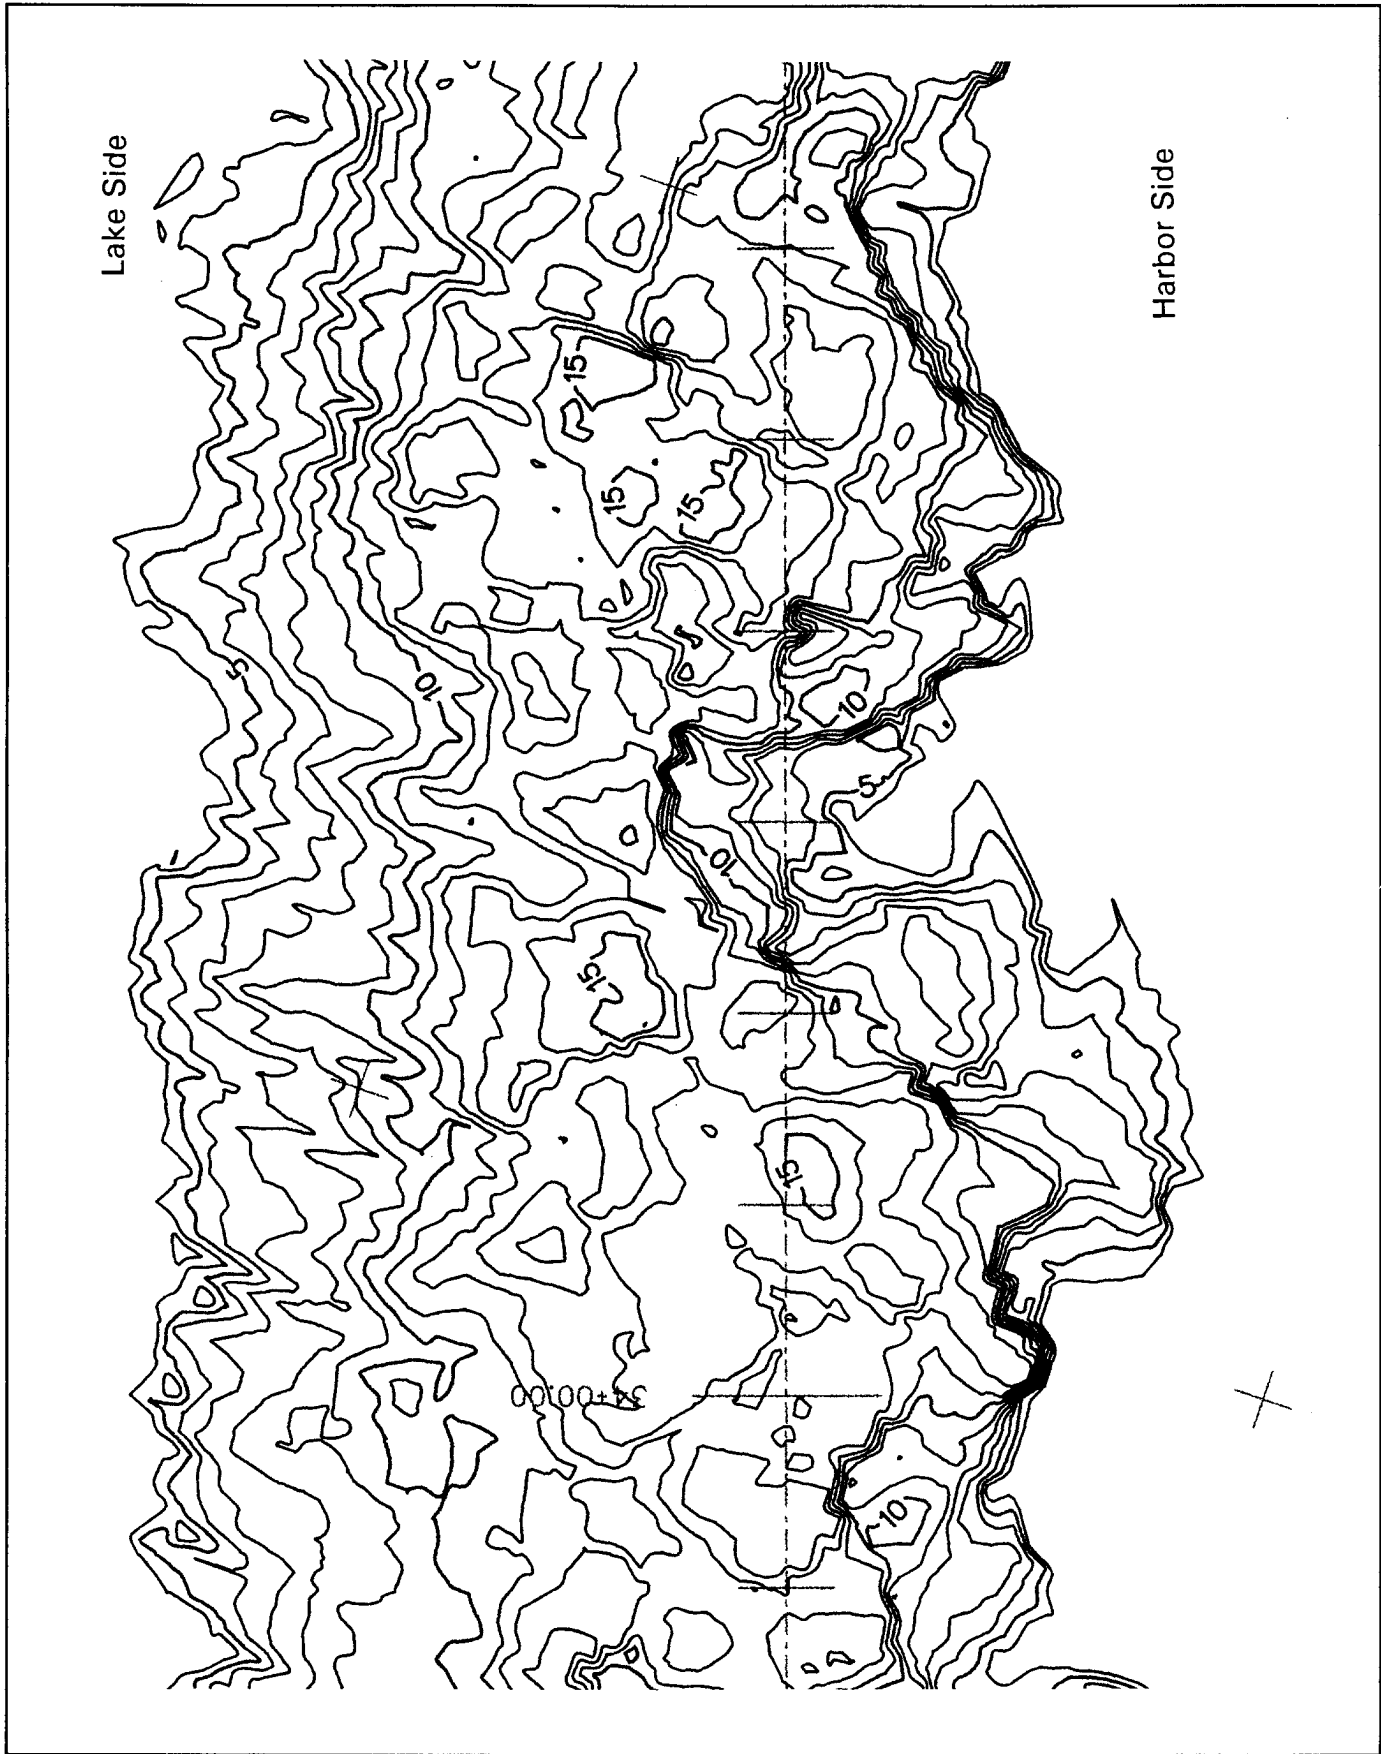
Figure A40. Topography of Burns Harbor North Breakwater, sta 33+30-34+15

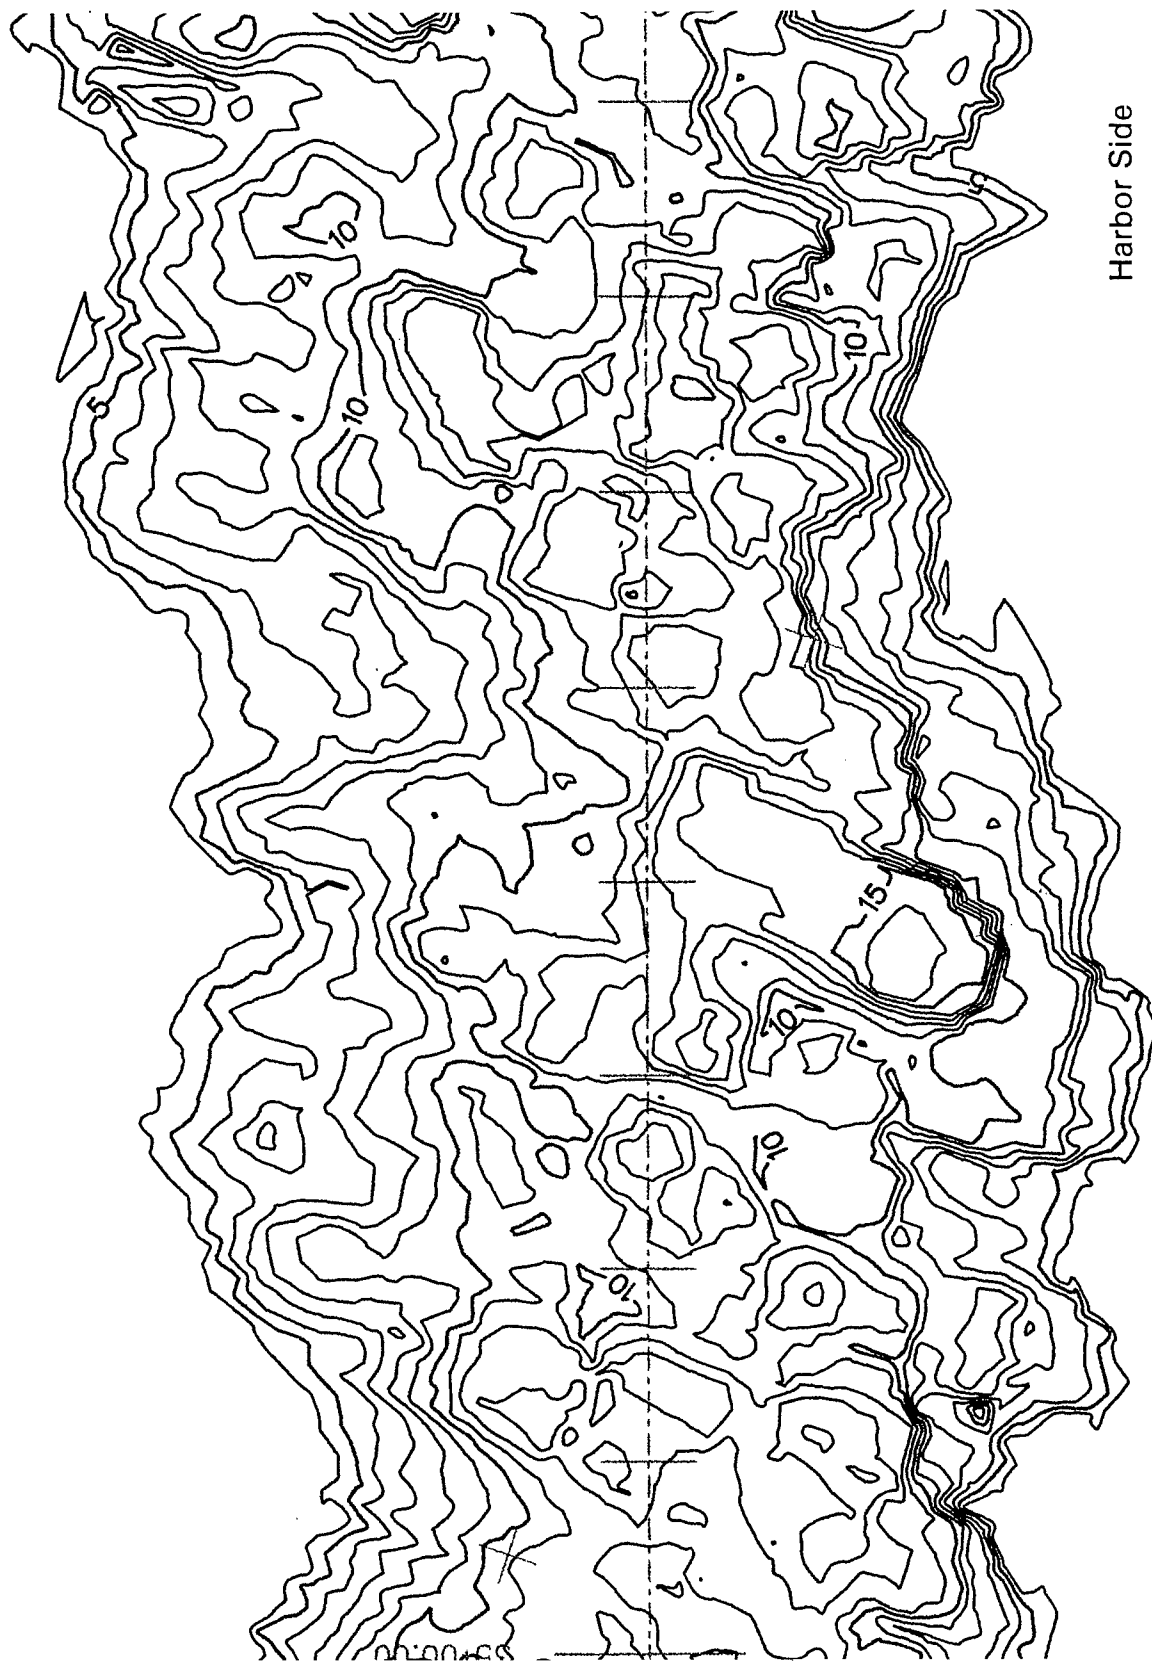
Figure A41. Topography of Burns Harbor North Breakwater, sta 34+15-35+00
